**Flood Control Project Maintenance  
Levee Inspections****LMA District Cover Sheet****Spring 2016 Levee Inspection Results****Reclamation District No. 0501 Ryer Island**

**Spring 2016 Levee Inspection Results**

**Reclamation District No. 0501 Ryer Island**

Waterway			Bank	Unit Miles
Unit No. 01 Steamboat Slough			Right	6.71
	Spring (March - May)	Summer (June - August)	(September - November) Fall	Winter (December - February)
Unit Maintenance Rating (Fall Only)				
Date of Inspection	3/24/2016 - 3/24/2016			
DWR Inspector	Herman Phillips			
Accompanied By	Nicolas Zepeda RD 501

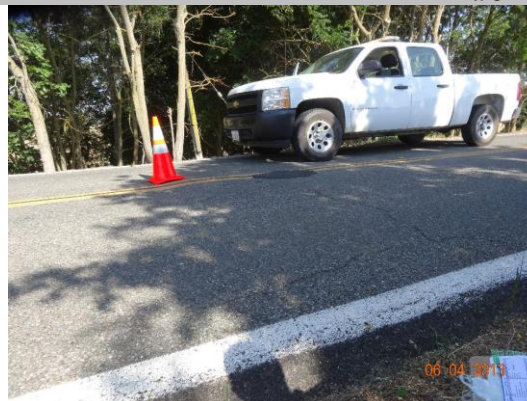
Photo 1 of 2 : UCIP\_SP\_2016\_44766\_58923.jpg

View of crown at crossing.

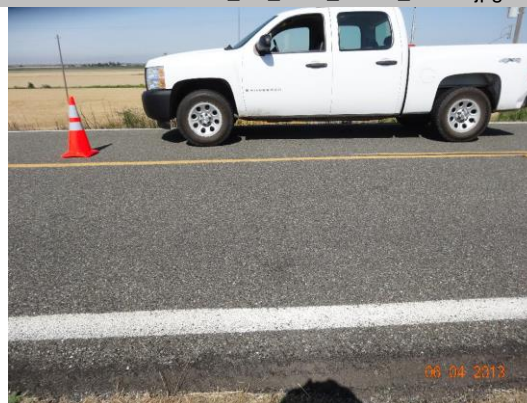
Photo 1 of 2 : UCIP\_SP\_2016\_32524\_58928.jpg

LM Start	0.39	Rating **	M	Issue No.	980
LM End	0.39	Issue Type +	En	Location *	LS
Category	Supplemental			GPS Latitude/Longitude	
				Start	End
Item	DWR UCIP Field Study			38.249197 °	38.249197 °
				-121.603061 °	-121.603061 °
DWR ID					
Comment Code					
Inspector Comment					
FS_ID:32524 DS_ID:21031 EP_NO: N/A Repair Type: Non-Urgent Crossing Status: Found UCIP Comments: Dense vegetation limits the inspector's visibility to identify signs of leaks through the slope. Recommend removing vegetation along pipe alignment for reinspection. Need to contact the owner to clear slope along crossing. FIELD_STRUCT_DESC: 20-inch and 2.5-inch pipes through the levee, both 7.8 feet below the crown. Pump in pump house on landward slope. Pipe exposed along waterward slope. (USACE-1959). This entry matches the Drainage or Irrigation Structure referenced in O&M manual (HLM 0.40). FS Date: 6/4/2013

View of crown

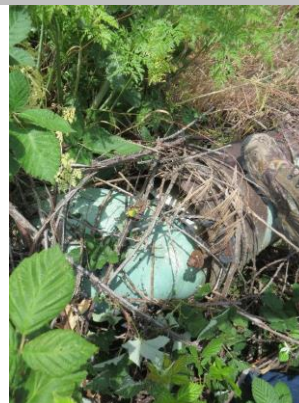
Photo 1 of 2 : UCIP\_SP\_2016\_44655\_73852.jpg

LM Start	0.97	Rating **	U	Issue No.	989
LM End	0.97	Issue Type +	En	Location *	LS
Category	Supplemental			GPS Latitude/Longitude	
				Start	End
Item	DWR UCIP Field Study			38.240808 °	38.240808 °
				-121.603628 °	-121.603628 °
DWR ID					
Comment Code					
Inspector Comment					
FS_ID:44655 DS_ID:21034 EP_NO: N/A Repair Type: Urgent Crossing Status: Found UCIP Comments: Unauthorized PVC pipe. Annular space not grouted. 14-inch pipe open on both ends. FIELD_STRUCT_DESC: 14-inch steel irrigation pipe through the levee, 3.2 feet below the crown. (USACE-1959). 10-inch PVC pipe sleeved through 14-inch with a siphon breaker on the LS shoulder. This entry matches the Drainage or Irrigation Structure referenced in O&M manual (HLM 1.0). FS Date: 4/21/2015

10-inch PVC pipe sleeved through 14-inch steel pipe on WS slope. No grout identified.

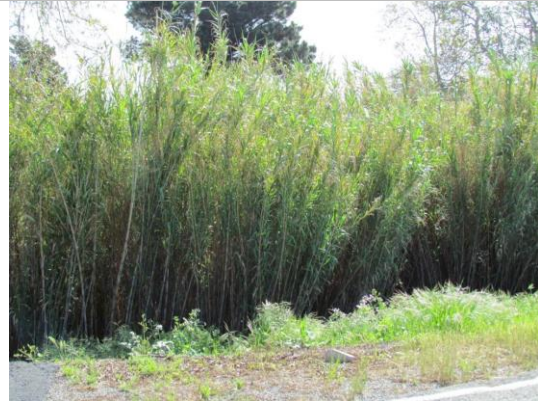
Photo 1 of 1 : SP\_2016\_RD0501\_169\_51\_20160404\_00060.jpg

LM Start	1.55	Rating **	U	Issue No.	51
LM End	1.74	Issue Type +	Ma	Location *	LS
Category	Earthen Levee			GPS Latitude/Longitude	
				Start	End
Item	Vegetation			38.232577 °	38.229883 °
				-121.603480 °	-121.603927 °
DWR ID	DWR_RD0501_01_s_2016_51				
Comment Code					
V2 : Remove the wild growth other than native grasses from the levee slopes.					
Inspector Comment					
Remove the bamboo from the levee section.

Looking downstream the landside shoulder tall bamboo present on the slope.

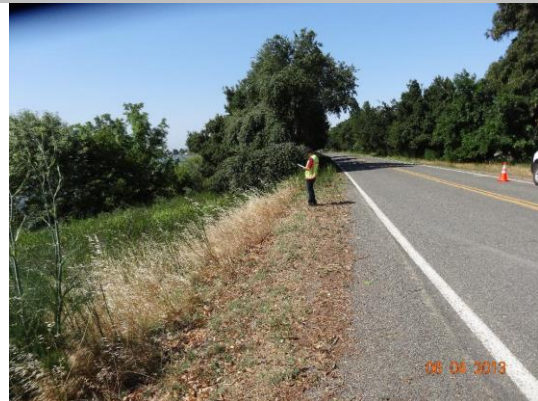
Photo 1 of 2 : UCIP\_SP\_2016\_32526\_58933.jpg

FS\_ID:32526  
DS\_ID:21022  
EP\_NO: 2742  
Repair Type: Non-Urgent  
Crossing Status: Found  
UCIP Comments: Dense vegetation limits the inspector's visibility to identify signs of pipe failure (leaks) through the levee slopes. Recommend removing vegetation along pipe alignment to conduct proper inspection of structure and appurtenances. Additional notes: pump was running during inspection, 16-inch pipe debris section located on landward side, view of standpipe and support structure on waterward side does not match structure description--need to determine if crossing has been altered.  
FIELD\_STRUCT\_DESC: 16-inch drainpipe through the levee, 3.6 feet below the crown. Cutoff walls around pipe at center of levee. Siphon breaker on apex of pipe at landward shoulder. Pump house on landward shoulder. Pipe discharges into 48-inch pipe with screw gate on landward side. (Permit No. 2742-1959). Repairs made to pipe and a portion replaced, from landward shoulder to discharge end on waterward side, under Permit No. 15380 (1999). Rock revetment placed on waterward slope. Revegetation in progress on waterside.

Overview of crown at crossing, looking downstream.

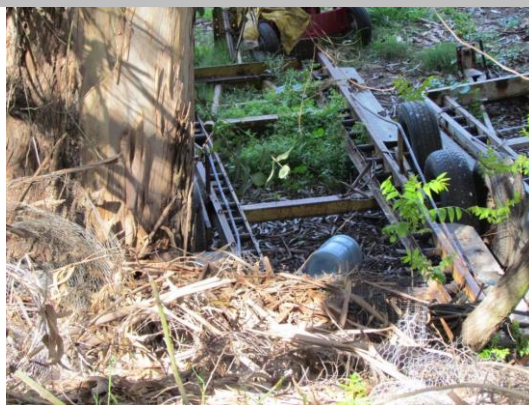
Photo 1 of 2 : SP\_2016\_RD0501\_169\_63\_20160404\_00061.jpg

LM Start	3.24	Rating **	U	Issue No.	63
LM End	3.24	Issue Type +	En	Location *	LS
Category	Earthen Levee			GPS Latitude/Longitude	
				Start	End
Item	Encroachments			38.209811 °	38.209713 °
				-121.610813 °	-121.610882 °
DWR ID	DWR_RD0501_01_f_2012_63				
Comment Code					
MA : Material					
Inspector Comment					
There is firewood and other material placed within the landside easement that need to be removed.

Equipment within the landside easement.

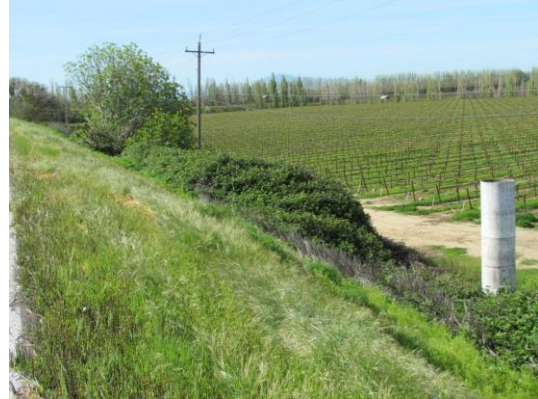
Photo 1 of 1 : SP\_2016\_RD0501\_169\_66\_20160404\_00067.jpg

LM Start	3.44	Rating **	U	Issue No.	66
LM End	3.63	Issue Type +	Ma	Location *	LS
Category	Earthen Levee			GPS Latitude/Longitude	
				Start	End
Item	Vegetation			38.206953 °	38.204293 °
				-121.612042 °	-121.613052 °
DWR ID	DWR_RD0501_01_s_2016_66				
Comment Code					
V2 : Remove the wild growth other than native grasses from the levee slopes.					
Inspector Comment					
Remove the wild berries from the levee slope and toe landward.

Looking downstream from the landside slope levee mile 3.44 wild berries present along the slope and toe.

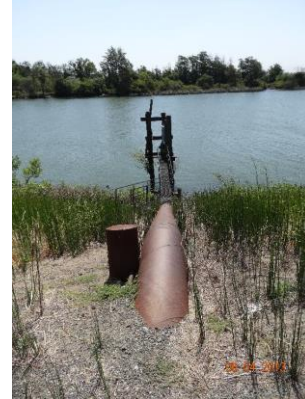
Photo 2 of 2 : UCIP\_SP\_2016\_32529\_58951.jpg

View of waterward side--siphon breaker, walkway, platform, pump, and control panel.

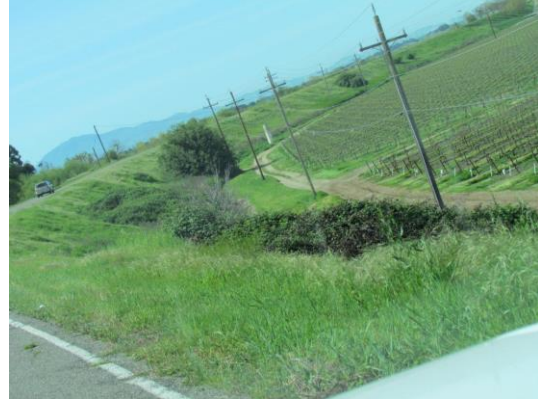
Photo 1 of 1 : SP\_2016\_RD0501\_169\_69\_20160404\_00071.jpg

LM Start	4.14	Rating **	U	Issue No.	69
LM End	4.17	Issue Type +	Ma	Location *	LS
Category	Earthen Levee			GPS Latitude/Longitude	
				Start	End
Item	Vegetation			38.197492 °	38.197160 °
				-121.616340 °	-121.616675 °
DWR ID	DWR_RD0501_01_s_2016_69				
Comment Code					
V2 : Remove the wild growth other than native grasses from the levee slopes.					
Inspector Comment					
Remove these wild berries from the landside slope and toe.

Berry vines present on the toe of the landside slope and toe.

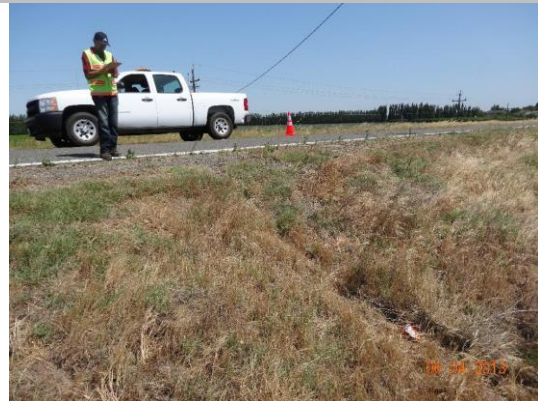
Photo 1 of 2 : UCIP\_SP\_2016\_19644\_33328.jpg

Comment Code					
Inspector Comment					
FS_ID:19644 DS_ID:21016 EP_NO: N/A Repair Type: Non-Urgent Crossing Status: Found UCIP Comments: Pipe section was altered/modified through levee crown. 12-inch pipe sleeved through existing pipe. Dense vegetation limits the inspector's visibility to identify signs of pipe failure (leaks) through the slope. Additional Notes: electrical conduit is disconnected on landside. Recommend removing vegetation along pipe alignment to conduct proper inspection of structure and appurtenances. Also need to contact owner to obtain maintenance records for crossing--need permit authorizing modifications. FIELD_STRUCT_DESC: 14-inch pipe through the levee, 3.2 feet below the crown. 12-inch pipe sleeved through existing 14-inch pipe and annular space grouted. 1.5-inch electrical conduit runs parallel along 14-inch pipe. Pump on pile structure in channel. Walkway to pump. (USACE-1959). This entry matches the Drainage or Irrigation Structure referenced in O&M manual (HLM 4.30). FS Date: 6/4/2013

View of waterward side.

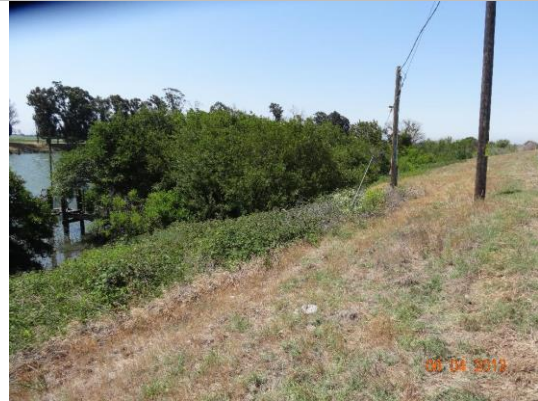
Photo 2 of 2 : UCIP\_SP\_2016\_19644\_33331.jpg

Item	DWR UCIP Field Study			38.196176 °	38.196176 °	
				-121.617898 °	-121.617898 °	
DWR ID						
Comment Code						
Inspector Comment						
FS_ID:19644 DS_ID:21016 EP_NO: N/A Repair Type: Non-Urgent Crossing Status: Found UCIP Comments: Pipe section was altered/modified through levee crown. 12-inch pipe sleeved through existing pipe. Dense vegetation limits the inspector's visibility to identify signs of pipe failure (leaks) through the slope. Additional Notes: electrical conduit is disconnected on landside. Recommend removing vegetation along pipe alignment to conduct proper inspection of structure and appurtenances. Also need to contact owner to obtain maintenance records for crossing--need permit authorizing modifications. FIELD_STRUCT_DESC: 14-inch pipe through the levee, 3.2 feet below the crown. 12-inch pipe sleeved through existing 14-inch pipe and annular space grouted. 1.5-inch electrical conduit runs parallel along 14-inch pipe. Pump on pile structure in channel. Walkway to pump. (USACE-1959). This entry matches the Drainage or Irrigation Structure referenced in O&M manual (HLM 4.30). FS Date: 6/4/2013

Overview of waterward side--pump station, platform, &amp; power pole.

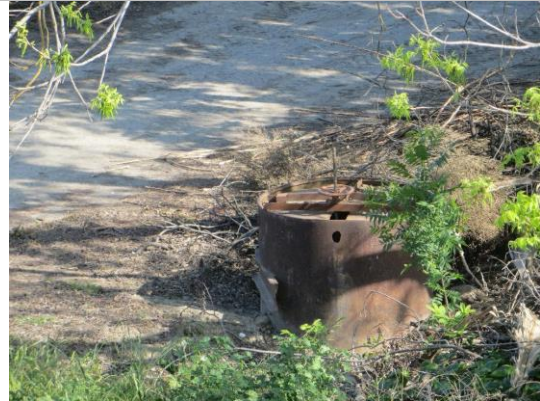
Photo 2 of 2 : UCIP\_SP\_2016\_44726\_73921.jpg

Item	DWR UCIP Field Study			38.195009 °	38.195009 °	
				-121.631548 °	-121.631548 °	
DWR ID						
Comment Code						
Inspector Comment						
FS_ID:44726						
DS_ID:21018						
EP_NO: N/A						
Repair Type: Non-Urgent						
Crossing Status: Found						
UCIP Comments: Crossing appears abandoned as there are no connections at siphon pump on LS shoulder. If it is abandoned it should be done so properly.						
FIELD_STRUCT_DESC: 14-inch steel irrigation pipe sleeved through a 16-inch steel pipe through the levee, 3-feet below the crown. Annular space grouted. Siphon pump/breaker on landward shoulder. Steel standpipe with slidegate at landward toe. (USACE-1959). This entry matches the Drainage or Irrigation Structure referenced in O&M manual (HLM 5.40).						
FS Date: 4/23/2015

Steel standpipe and gatevalve on LS toe.

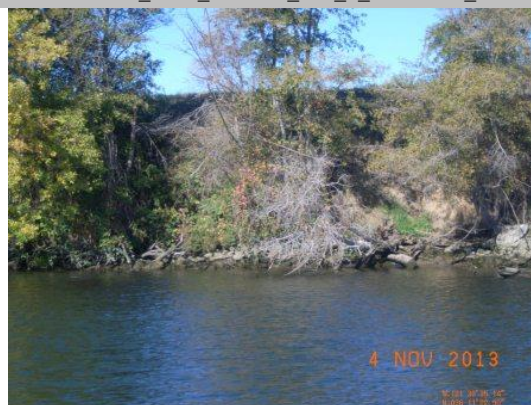
Photo 1 of 1 : SP\_2016\_RD0501\_169\_1\_20160223\_00001.jpg

LM Start	5.77	Rating **	M	Issue No.	1
LM End	5.84	Issue Type +	Ma	Location *	WS
Category	Supplemental			GPS Latitude/Longitude	
				Start	End
Item	2015 USACE Erosion Survey, DRAFT			38.190001 °	38.189311 °
				-121.643160 °	-121.643917 °
DWR ID	DWR_RD0501_01_s_2016_1				
Comment Code					
Inspector Comment					
2008 - Overstepped levee section with multiple small pockets of erosion 10 - 20 ft wide. 2013 - Site has fresh erosion and taller vertical sections. 2015: No observed changes. [2015 Site ID: STM_15-7_R]

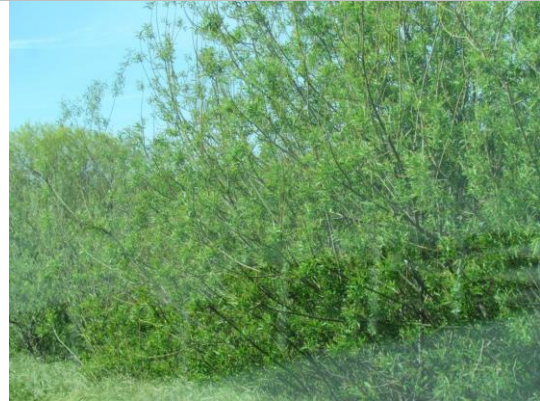
Photo 1 of 1 : SP\_2016\_RD0501\_169\_72\_20160504\_00072.jpg

LM Start	5.88	Rating **	U	Issue No.	72
LM End	5.93	Issue Type +	Ma	Location *	LS
Category	Earthen Levee			GPS Latitude/Longitude	
				Start	End
Item	Vegetation			38.188912 °	38.188380 °
				-121.644687 °	-121.645243 °
DWR ID	DWR_RD0501_01_s_2016_72				
Comment Code					
V7 : Trees / Woody Vegetation					
Inspector Comment					
Control the woody tree growth on the landside slope.

Looking downstream from the landside slope levee mile 5.88 to 5.93 woody tree growth on the levee section.

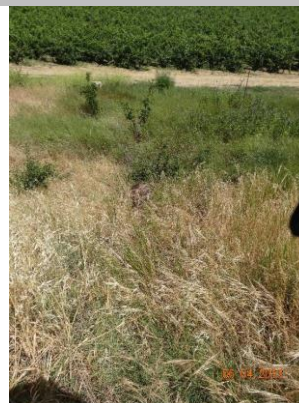
Photo 1 of 2 : UCIP\_SP\_2016\_32530\_58957.jpg

Comment Code					
Inspector Comment					
FS_ID:32530 DS_ID:21020 EP_NO: N/A Repair Type: Non-Urgent Crossing Status: Found UCIP Comments: Dense vegetation limits the inspector's visibility to identify signs of pipe failure (leaks) through the slope. Recommend removing vegetation along pipe alignment to conduct proper inspection of structure and appurtenances. If structure is no longer used--Need to contact owner to determine status. If crossing is no longer used owner will need to coordinate with CVFPB. FIELD_STRUCT_DESC: Abandoned 16-inch pipe through the levee, 6.5 feet below the crown. Siphon breaker and service pole on landward shoulder. Electrical box on landside toe. Pump on pile stucture in channel. FS Date: 6/4/2013

Abandoned 16-inch pipe on landward side.

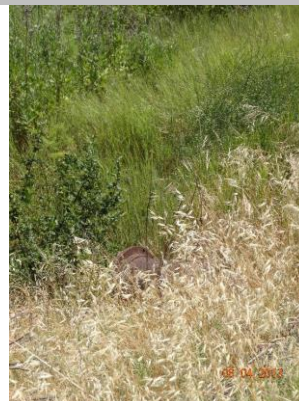
Photo 2 of 2 : UCIP\_SP\_2016\_32530\_58956.jpg

Item	DWR UCIP Field Study			38.183961 °		38.183961 °
				-121.656860 °		-121.656860 °
DWR ID						
Comment Code						
Inspector Comment						
FS_ID:32530						
DS_ID:21020						
EP_NO: N/A						
Repair Type: Non-Urgent						
Crossing Status: Found						
UCIP Comments: Dense vegetation limits the inspector's visibility to identify signs of pipe failure (leaks) through the slope. Recommend removing vegetation along pipe alignment to conduct proper inspection of structure and appurtenances. If structure is no longer used--Need to contact owner to determine status. If crossing is no longer used owner will need to coordinate with CVFPB.						
FIELD_STRUCT_DESC: Abandoned 16-inch pipe through the levee, 6.5 feet below the crown. Siphon breaker and service pole on landward shoulder. Electrical box on landside toe. Pump on pile stucture in channel.						
FS Date: 6/4/2013

Overview of waterward side--section of pipe visible through dense vegetation.

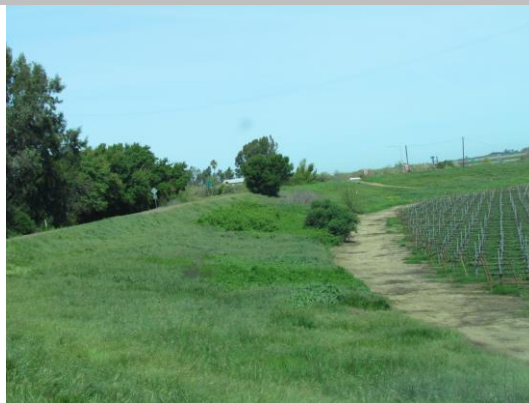
Photo 1 of 1 : SP\_2016\_RD0501\_170\_21\_20160504\_00043.jpg

LM Start	0.00	Rating **	M	Issue No.	21
LM End	0.00	Issue Type +	Ma	Location *	LS
Category	Earthen Levee			GPS Latitude/Longitude	
				Start	End
Item	Vegetation			38.188260 °	38.188260 °
				-121.648701 °	-121.648700 °
DWR ID	DWR_RD0501_02_s _ 2012_21				
Comment Code					
V2 : Remove the wild growth other than native grasses from the levee slopes.					
Inspector Comment					
Mow the tall weeds at toe of levee slope.

Looking downstream from levee mile 0.00 at the landside slope tall weeds present on the slope and toe.

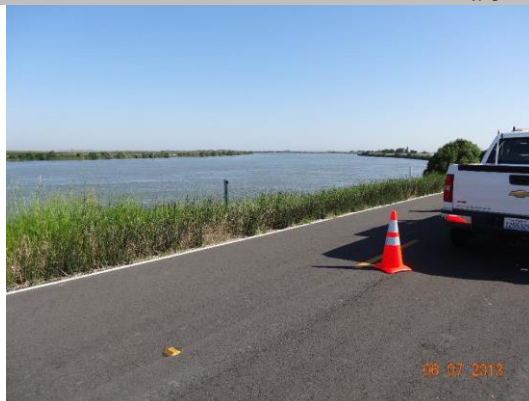
Photo 1 of 2 : UCIP\_SP\_2016\_32531\_58960.jpg

Comment Code					
Inspector Comment					
FS_ID:32531 DS_ID:21035 EP_NO: N/A Repair Type: Non-Urgent Crossing Status: Found UCIP Comments: Dense vegetation limits the inspector's visibility to identify signs of pipe failure (leaks) through the slope. Recommend removing vegetation along pipe alignment to conduct proper inspection of structure and appurtenances. Need to determine owner and status of crossing. FIELD_STRUCT_DESC: 10-inch pipe sleeved through a 12-inch pipe through the levee, 5.0 feet below the crown. Pump on waterward side. (USACE-1959). This entry matches the Drainage or Irrigation Structure referenced in O&M manual (HLM 0.60). FS Date: 6/7/2013

View of crown.

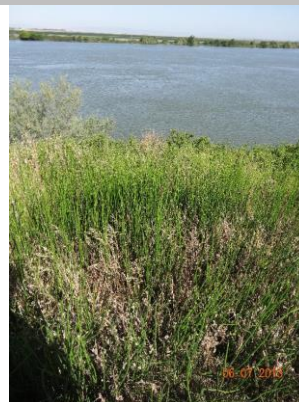
Photo 2 of 2 : UCIP\_SP\_2016\_32531\_58958.jpg

Overview of waterward side. Inaccessible due to dense vegetation.

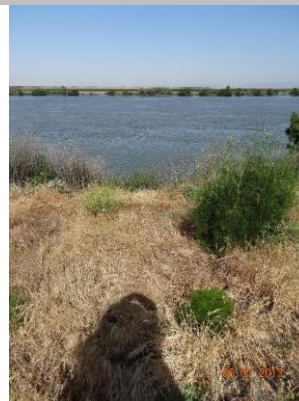
Photo 1 of 2 : UCIP\_SP\_2016\_32532\_58967.jpg

FS\_ID:32532  
DS\_ID:21092  
EP\_NO: 3703  
Repair Type: Urgent  
Crossing Status: Found  
UCIP Comments: Deteriorated pipe with holes present at intake. Dense vegetation limits the inspector's visibility to identify signs of pipe failure (leaks) through the slope. Recommend removing vegetation along pipe alignment to conduct proper inspection of structure and appurtenances. If crossing is no longer used --owner will need coordinate with CVFPB to address crossing. Need to coordinate with DWR Inspector and CVFPB.  
FIELD\_STRUCT\_DESC: 8-inch steel pipe through the levee, 1.7 feet below the crown. Siphon breaker on apex of pipe at landward shoulder. Pipe discharges into concrete sump near landward toe. Pipe is exposed along landward slope. 8-inch pipes are approximately 1 foot apart on landward side. (Permit No. 3703-1961)  
FS Date: 6/7/2013

Overview of waterward side--20 foot berm present.

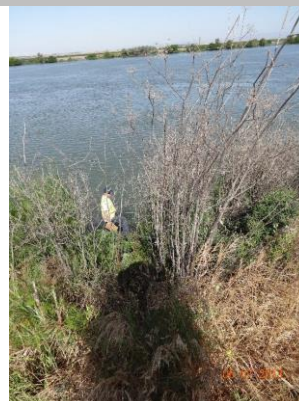
Photo 2 of 2 : UCIP\_SP\_2016\_32532\_58965.jpg

View of waterward side. Inspector is standing near exposed section of pipe at levee toe.

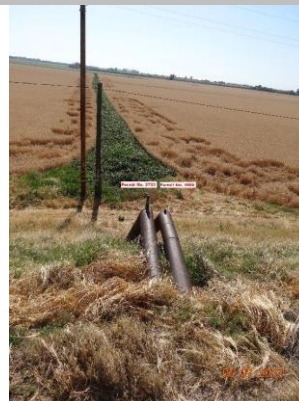
Photo 1 of 2 : UCIP\_SP\_2016\_32533\_58968.jpg

FS\_ID:32533  
DS\_ID:21036  
EP\_NO: 1902  
Repair Type: Urgent  
Crossing Status: Found  
UCIP Comments: Reason for an Urgent Priority is due to adjacent crossing--adjacent crossing has holes present and is was installed in the 1960s. Our records show this pipe was installed before 1955. Dense vegetation limits the inspector's visibility to identify signs of pipe failure (leaks) through the slope. Recommend removing vegetation along pipe alignment to conduct proper inspection of structure and appurtenances. If crossing is no longer in use--Owner will need to coordinate with DWR Inspector and CVFPB. Need to determine condition of pipe--request maintenance records from owner once found--this crossing could be capped and grouted--NEED RECORDS.  
FIELD\_STRUCT\_DESC: 8-inch steel pipe through the levee, 1.7 feet below the crown. Siphon breaker on apex of pipe at landward shoulder. Pipe discharges into concrete sump near landward toe. Pipe is exposed along landward slope. (USACE-1959). This entry matches the Drainage or Irrigation Structure referenced in O&M manual (HLM 0.90). Section of pipe, between both shoulders, was removed and replaced with a 10-inch steel pipe under Permit No. 1902 (1959).

8-inch pipes approximately 1 foot apart.

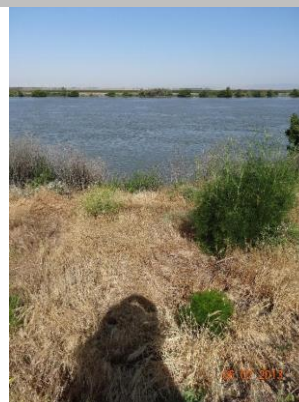
Photo 2 of 2 : UCIP\_SP\_2016\_32533\_58970.jpg

Overview of waterward side--20 foot berm present.

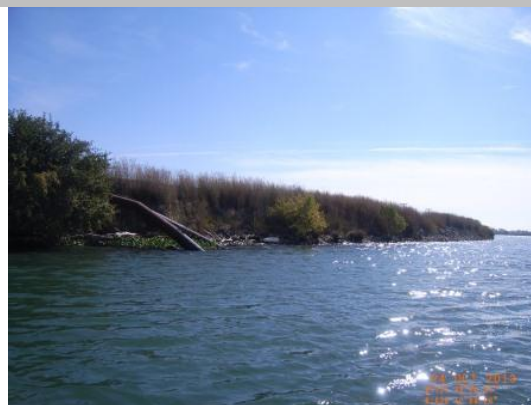
Photo 1 of 1 : SP\_2016\_RD0501\_170\_1\_20160223\_00001.jpg

LM Start	1.10	Rating **	M	Issue No.	1
LM End	1.17	Issue Type +	Ma	Location *	WS
Category	Supplemental			GPS Latitude/Longitude	
				Start	End
Item	2015 USACE Erosion Survey, DRAFT			38.199128 °	38.200146 °
				-121.655881 °	-121.655638 °
DWR ID	DWR_RD0501_02_s_2016_1				
Comment Code					
Inspector Comment					
2005 - Large vertical sections due to wave wash. New stone dumped on the bank with exposed geotextile. Cohesive toe has thin weak stratigraphic unit that is washing out. 2006 - Partially repaired, but 100 ft in the middle of the reach has exposed filter fabric and stone riprap is gone. 2010 - Site extended downstream to include new erosion pocket. 2015: No observed changes. [2015 Site ID: CHS_15-9_L]

USACE 2013 Photo #1

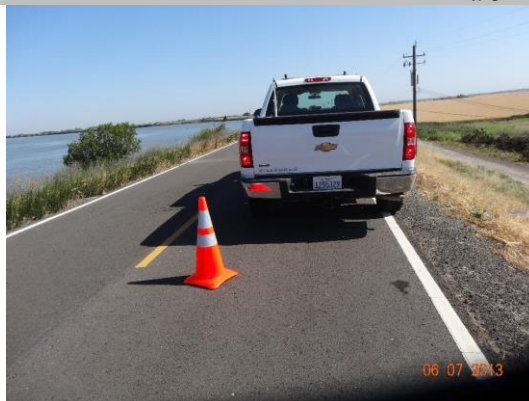
Photo 1 of 2 : UCIP\_SP\_2016\_44865\_58975.jpg

Comment Code					
Inspector Comment					
FS_ID:44865 DS_ID:21038 EP_NO: 2817 Repair Type: Non-Urgent Crossing Status: Found UCIP Comments: Dense vegetation limits the inspector's visibility to identify signs of pipe failure (leaks) through the slope. Recommend removing vegetation along pipe alignment to conduct proper inspection of structure and appurtenances. Scour hole located on waterward side. FIELD_STRUCT_DESC: 20-inch steel drainpipe sleeved through a 24-inch steel pipe through the levee, 9.0 feet below the crown. Flap gate on waterward end. Two cutoff collars around the pipe at both shoulders. Pipe exposed along both slopes. Rock revetment on waterward slope. Berm on waterward side is over 20 feet. (Permit No. 2817-1959) FS Date: 6/7/2013

View of levee crown at crossings.

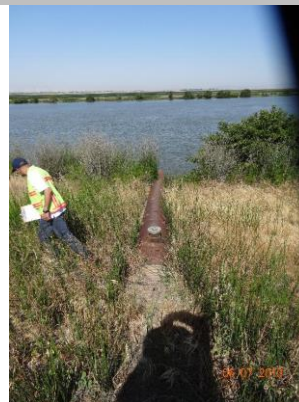
Photo 2 of 2 : UCIP\_SP\_2016\_44865\_58972.jpg

View of waterward side--pipe section exposed and siphon breaker. Over 20 feet berm on waterward side.

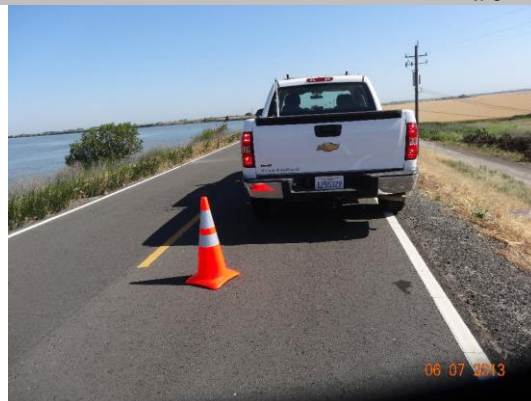
Photo 1 of 2 : UCIP\_SP\_2016\_44866\_58981.jpg

LM Start	1.16	Rating **	M	Issue No.	39
LM End	1.16	Issue Type +	En	Location *	WS
Category	Supplemental			GPS Latitude/Longitude	
				Start	End
Item	DWR UCIP Field Study			38.199837 °	38.199837 °
				-121.655391 °	-121.655391 °
DWR ID					
Comment Code					
Inspector Comment					
FS_ID:44866 DS_ID:21094 EP_NO: 14491 Repair Type: Non-Urgent Crossing Status: Found UCIP Comments: Dense vegetation limits the inspector's visibility to identify signs of pipe failure (leaks) through the slope. Recommend removing vegetation along pipe alignment to conduct proper inspection of structure and appurtenances. Scour hole present on waterward side. FIELD_STRUCT_DESC: 24-inch steel drainpipe through the levee, 4.5 feet below the crown. Cutoff wall around pipe at center of levee. Siphon breaker on apex of pipe at waterward shoulder. Pump on landward side. (Permit No. 14491-1986) FS Date: 6/7/2013

View of downstream crown.

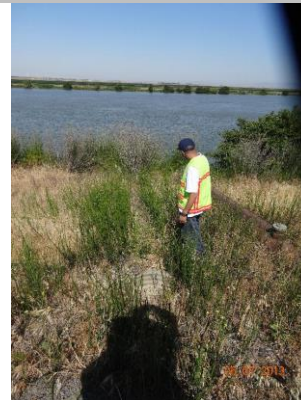
Photo 2 of 2 : UCIP\_SP\_2016\_44866\_58979.jpg

Two pipes on waterside.

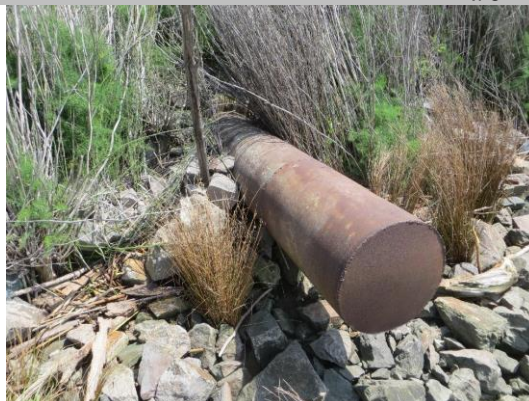
Photo 1 of 2 : UCIP\_SP\_2016\_44753\_73955.jpg

LM Start	1.25	Rating **	M	Issue No.	35
LM End	1.25	Issue Type +	En	Location *	WS
Category	Supplemental			GPS Latitude/Longitude	
				Start	End
Item	DWR UCIP Field Study			38.201143 °	38.201143 °
				-121.655169 °	-121.655169 °
DWR ID					
Comment Code					
Inspector Comment					
FS_ID:44753 DS_ID:21085 EP_NO: N/A Repair Type: Non-Urgent Crossing Status: Found UCIP Comments: Hole rusted through pipe on WS end. Pipe abandoned and should be done so properly. FIELD_STRUCT_DESC: Abandoned 20-inch steel pipe through the levee, 15.5 feet below the crown. Pipe exposed along waterward slope, Steel plate welded over end (USACE-1959). This entry matches the Drainage or Irrigation Structure referenced in O&M manual (HLM 1.40). FS Date: 4/23/2015

20-inch pipe with welded steel plate over end on WS toe.

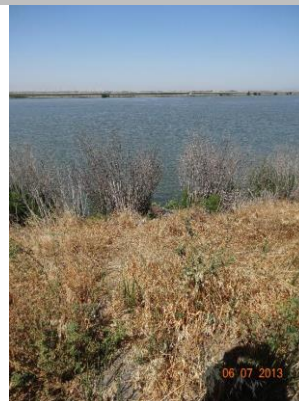
Photo 1 of 2 : UCIP\_SP\_2016\_44867\_58987.jpg

Comment Code					
Inspector Comment					
FS_ID:44867 DS_ID:21093 EP_NO: 13520 Repair Type: Non-Urgent Crossing Status: Found UCIP Comments: Dense vegetation limits the inspector's visibility to identify signs of pipe failure (leaks) through the slope. Recommend removing vegetation along pipe alignment to conduct proper inspection of structure and appurtenances. Owner needs to be informed about the vegetation clearance required for proper inspection. FIELD_STRUCT_DESC: 18-inch steel pipe through the levee, 3.4 feet below the crown. Steel cutoff wall around pipe at center of levee. Siphon breaker on apex of pipe on landward shoulder. Pipe extends from sump off of landward toe. Pipe exposed along waterward slope. Rock revetment on waterward slope. (Permit No. 13520-1982) FS Date: 6/7/2013

Overview of waterside. Dense vegetation.

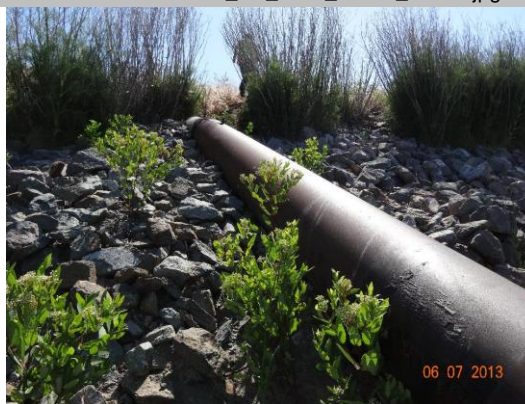
Photo 2 of 2 : UCIP\_SP\_2016\_44867\_58982.jpg

View of waterward side--pipe extends from berm to river.

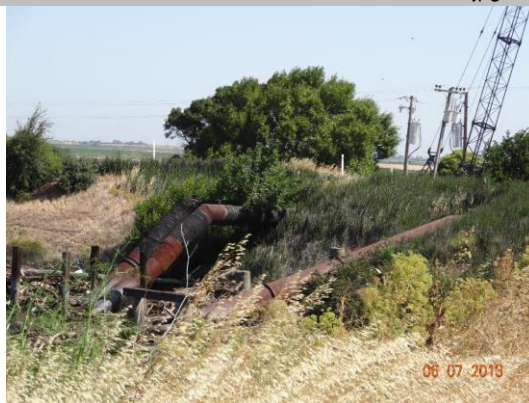
Photo 2 of 2 : UCIP\_SP\_2016\_40489\_33359.jpg

FS\_ID:40489  
DS\_ID:21042  
EP\_NO: 15477  
Repair Type: Non-Urgent  
Crossing Status: Found  
UCIP Comments: Stacey Boyd, LMA superintendent for RD0501, confirmed the removal and replacement of existing crossing under new permit no. 18811. New crossing will be a 30-inch diameter discharge pipe above the design flood plane. Construction will start soon. Update record once the project is completed. Dense vegetation on both waterside and landside. Recommend removing vegetation along pipe alignment to conduct proper inspection of structure and appurtenances. FIELD\_STRUCT\_DESC: 42-inch steel pipe through the levee, 6.5 feet below the crown. Siphon breaker on waterward slope. Pump on the landward side (Permit No. 15477, 1990). Pipe exposed along both slopes. (USACE-1959). This entry matches the Drainage or Irrigation Structure referenced in O&M manual (HLM 2.0).  
FS Date: 6/7/2013

One 42-inch steel pipe with siphon break on waterside slope.

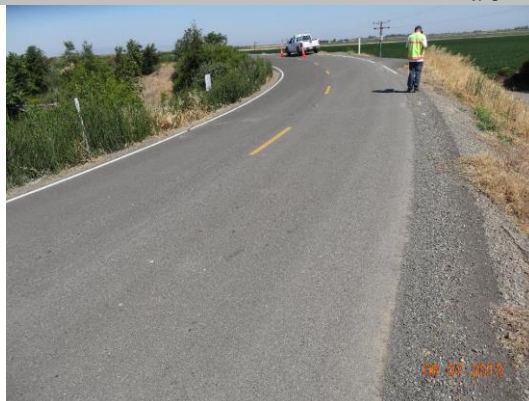
Photo 1 of 2 : UCIP\_SP\_2016\_47049\_33378.jpg

FS\_ID:47049  
DS\_ID:21091  
EP\_NO: 15477  
Repair Type: Non-Urgent  
Crossing Status: Found  
UCIP Comments: Dense vegetation limits the inspector's visibility to identify signs of pipe failure (leaks) through the slope. Recommend removing vegetation along pipe alignment to conduct proper inspection of structure and appurtenances.  
FIELD\_STRUCT\_DESC: 2 of 2: 36-inch steel pipe through the levee, 7.0 feet below the crown. Siphon breaker on waterward shoulder. Pumps on landward side. Pipe exposed along both slopes. Pipe supports at levee shoulders, were cutoff walls from pre-existing pipe (Permit No. 15477-1990) Dual 36-inch pipes are approximately 36-inches apart.  
FS Date: 6/7/2013

Overview of crown, looking downstream

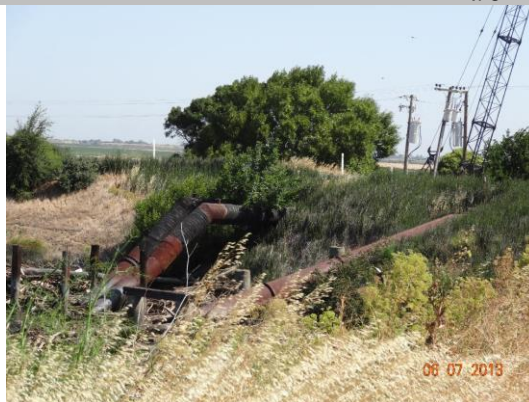
Photo 2 of 2 : UCIP\_SP\_2016\_47049\_33373.jpg

Overview of dual pipes on waterward side.

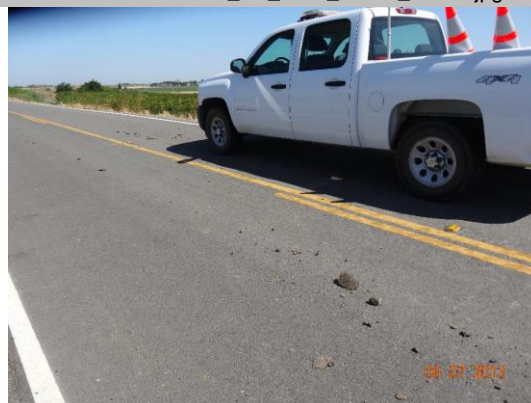
Photo 1 of 2 : UCIP\_SP\_2016\_32537\_58989.jpg

Comment Code					
Inspector Comment					
FS_ID:32537 DS_ID:21044 EP_NO: N/A Repair Type: Non-Urgent Crossing Status: Found UCIP Comments: Dense vegetation limits the inspector's visibility to identify signs of pipe failure (leaks) through the slope. Recommend removing vegetation along pipe alignment to conduct proper inspection of structure and appurtenances. FIELD_STRUCT_DESC: 14-inch steel pipe through the levee, 6.2 feet below the crown. Siphon breaker on waterward shoulder. (USACE-1959). This entry matches the Drainage or Irrigation Structure referenced in O&M manual (HLM 2.60). Pipe was repaired in 1984 under Permit No. 13937. The repair consisted of replacing the pipeline within the levee crown with new soil proofed steel pipe. FS Date: 6/7/2013

View of levee crown--narrow road.

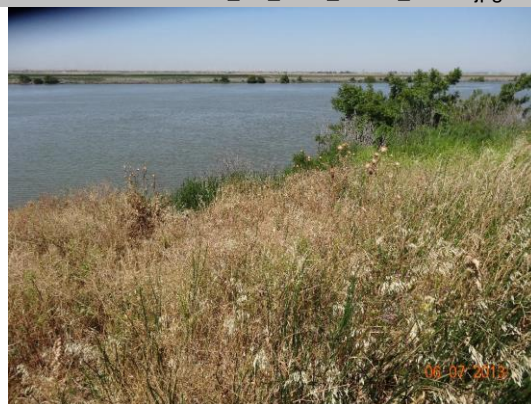
Photo 2 of 2 : UCIP\_SP\_2016\_32537\_58990.jpg

Photo taken just downstream of crossing looking at waterward side.

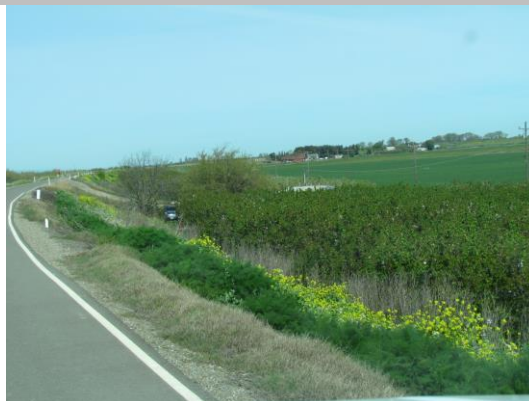
Photo 1 of 1 : SP\_2016\_RD0501\_170\_27\_20160504\_00042.jpg

LM Start	2.49	Rating **	U	Issue No.	27
LM End	3.38	Issue Type +	Ma	Location *	LS
Category	Earthen Levee			GPS Latitude/Longitude	
				Start	End
Item	Vegetation			38.213868 °	38.225330 °
				-121.665767 °	-121.672805 °
DWR ID	DWR_RD0501_02_s_2016_27				
Comment Code					
V2 : Remove the wild growth other than native grasses from the levee slopes.					
Inspector Comment					
Remove the wild berries from the levee section landward.

Standing at levee mile 2.49-3.38 looking downstream landside slope and toe wild berries present on the slope and toe.

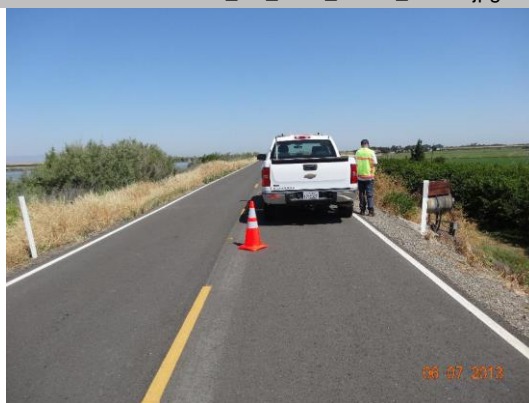
Photo 1 of 2 : UCIP\_SP\_2016\_44872\_33392.jpg

Comment Code					
Inspector Comment					
FS_ID:44872 DS_ID:21045 EP_NO: 4733 Repair Type: Non-Urgent Crossing Status: Found UCIP Comments: Dense vegetation limits the inspector's visibility to identify signs of pipe failure (leaks) through the waterward slope. Recommend removing vegetation along pipe alignment to conduct proper inspection of structure and appurtenances. FIELD_STRUCT_DESC: 18-inch pipe through the levee, 4.0 feet below the crown. Cutoff wall around pipe at center of levee. Siphon breaker on apex of pipe at landward shoulder. Rock revetment on waterward slope. 16-inch pipe welded to 18-inch pipe near landward shoulder, extends down landward slope. Pipe exposed along both slopes. (Permit No. 4733-1964) FS Date: 6/7/2013

View of levee crown at crossing.

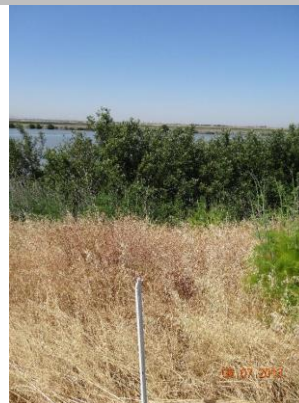
Photo 2 of 2 : UCIP\_SP\_2016\_44872\_33393.jpg

Comment Code						
Inspector Comment						
FS_ID:44872 DS_ID:21045 EP_NO: 4733 Repair Type: Non-Urgent Crossing Status: Found UCIP Comments: Dense vegetation limits the inspector's visibility to identify signs of pipe failure (leaks) through the waterward slope. Recommend removing vegetation along pipe alignment to conduct proper inspection of structure and appurtenances. FIELD_STRUCT_DESC: 18-inch pipe through the levee, 4.0 feet below the crown. Cutoff wall around pipe at center of levee. Siphon breaker on apex of pipe at landward shoulder. Rock revetment on waterward slope. 16-inch pipe welded to 18-inch pipe near landward shoulder, extends down landward slope. Pipe exposed along both slopes. (Permit No. 4733-1964) FS Date: 6/7/2013

Dense vegetation hindered inspection on waterward side.

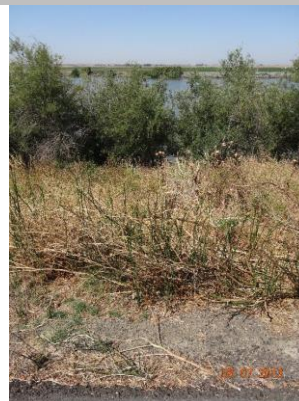
Photo 1 of 2 : UCIP\_SP\_2016\_19657\_33396.jpg

FS\_ID:19657  
DS\_ID:21046  
EP\_NO: N/A  
Repair Type: Non-Urgent  
Crossing Status: Found  
UCIP Comments: Dense vegetation limits the inspector's visibility to identify signs of pipe failure (leaks) through the waterward slope. Recommend removing vegetation along pipe alignment to conduct proper inspection of structure and appurtenances.  
FIELD\_STRUCT\_DESC: 16-inch pipe sleeved through a 20-inch pipe through the levee, 4.7 feet below the crown. Annular gap grouted. Siphon breaker on landward shoulder. Pipe exposed along both slopes. (USACE-1959). This entry matches the Drainage or Irrigation Structure referenced in O&M manual (HLM 3.30). The 16-inch pipe was sleeved through pre-existing pipe under Permit No. 2645 (1959).  
FS Date: 8/22/2013

Dense vegetation along the crown hinge point and beginning section of waterward slope.

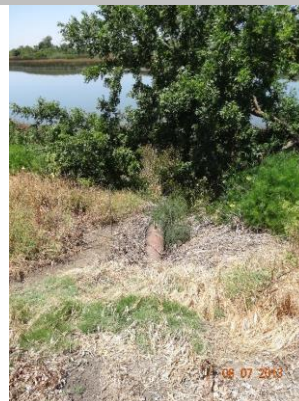
Photo 1 of 2 : UCIP\_SP\_2016\_44873\_33405.jpg

Comment Code					
Inspector Comment					
FS_ID:44873 DS_ID:21065 EP_NO: N/A Repair Type: Non-Urgent Crossing Status: Found UCIP Comments: Pump operating during inspection. Need to determine owner. Dense vegetation limits the inspector's visibility to identify signs of pipe failure (leaks) through the waterward slope. Recommend removing vegetation along pipe alignment to conduct proper inspection of structure and appurtenances. FIELD_STRUCT_DESC: 14-inch steel pipe through the levee, 6.3 feet below the crown instead of 16-inch pipe mentioned in O&M. Siphon breaker on landward slope. Pipe exposed on both slopes. (USACE-1959). This entry matches the Drainage or Irrigation Structure referenced in O&M manual (HLM 0.70). FS Date: 6/7/2013

Overview of waterward side. Dense vegetation limits proper inspection.

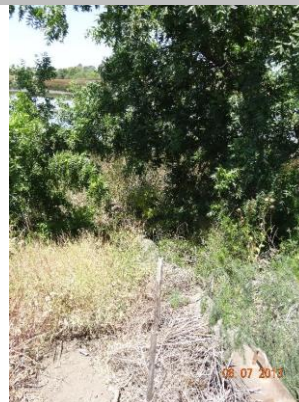
Photo 2 of 2 : UCIP\_SP\_2016\_44873\_33402.jpg

Conditions of waterward slope--dense vegetation along slope.

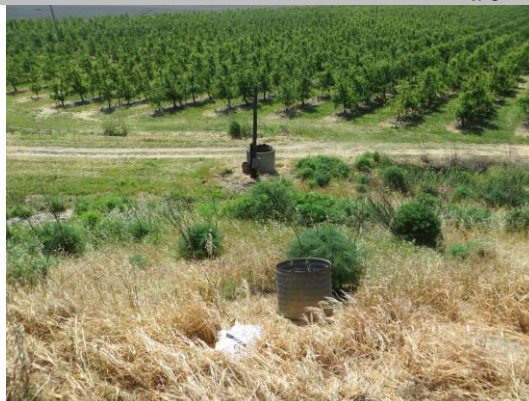
Photo 1 of 2 : UCIP\_SP\_2016\_44728\_73924.jpg

Comment Code					
Inspector Comment					
FS_ID:44728					
DS_ID:21066					
EP_NO: N/A					
Repair Type: Non-Urgent					
Crossing Status: Found					
UCIP Comments: Pipe appears abandoned and if so should be done so properly. Wooden walkway to pier in disrepair and a hazard.					
FIELD_STRUCT_DESC: 12-inch steel irrigation pipe through the levee, 8.0-feet below the crown. Siphon breaker on landward slope. Pump on pipe structure in stream. Concrete standpipe and distribution slide gates at landward toe. (USACE-1959). This entry matches the Drainage or Irrigation Structure referenced in O&M manual (HLM 1.50). 1.5-inch electrical conduit at same location.					
FS Date: 6/7/2013

Siphon breaker in 24-inch CMP riser on LS slope. Standpipe visible at LS toe.

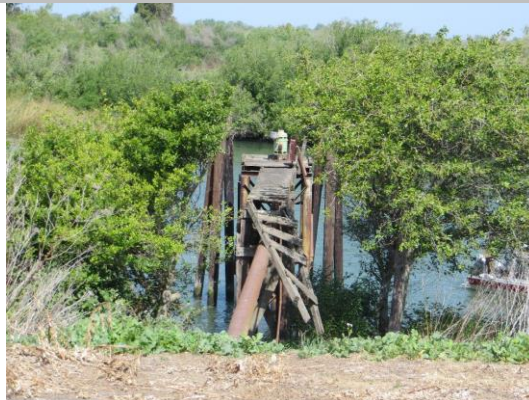
Photo 2 of 2 : UCIP\_SP\_2016\_44728\_73923.jpg

Pump on wooden pier off WS toe.

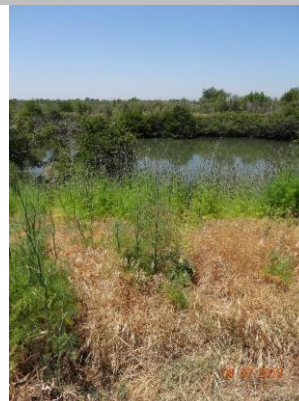
Photo 1 of 2 : UCIP\_SP\_2016\_43503\_33410.jpg

Comment Code					
Inspector Comment					
FS_ID:43503 DS_ID:21068 EP_NO: N/A Repair Type: Non-Urgent Crossing Status: Found UCIP Comments: Authorized or Unauthorized? Need permit authorizing work. Dense vegetation limits the inspector's visibility to identify signs of pipe failure (leaks) through the slope on both waterward and landward side. Recommend removing vegetation along pipe alignment to conduct proper inspection of structure and appurtenances. FIELD_STRUCT_DESC: 10-inch steel pipe through the levee, 6.3 feet below the crown. Pump, gate valve and switch box on waterward slope. Originally reported as 3.8-feet below crown in O+M manual, 1959 at HLM: 2.0. FS Date: 6/7/2013

Overview of waterward side. Pipe is completely obstructed by dense vegetation.

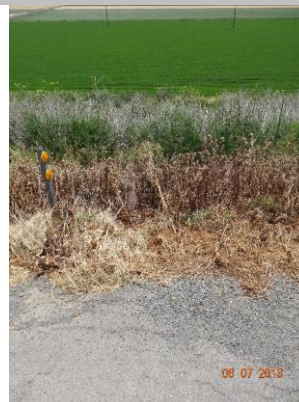
Photo 2 of 2 : UCIP\_SP\_2016\_43503\_33411.jpg

Overview of landward side. Pipe is visible however dense vegetation limits proper inspection.

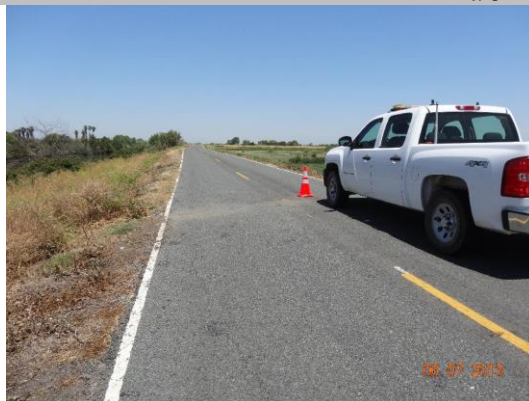
Photo 1 of 2 : UCIP\_SP\_2016\_18945\_31607.jpg

LM Start	2.52	Rating **	M	Issue No.	131
LM End	2.52	Issue Type +	En	Location *	LS
Category	Supplemental			GPS Latitude/Longitude	
				Start	End
Item	DWR UCIP Field Study			38.256255 °	38.256255 °
				-121.651551 °	-121.651551 °
DWR ID					
Comment Code					
Inspector Comment					
FS_ID:18945 DS_ID:21047 EP_NO: N/A Repair Type: Non-Urgent Crossing Status: Found UCIP Comments: Need to determine owner of structure. Recommend removing vegetation along pipe alignment to conduct proper inspection of structure and appurtenances. FIELD_STRUCT_DESC: 16-inch steel pipe through the levee, 3.3 feet below the crown. Gate valve and switch box on landward slope. Pipe exposed on both slopes. (USACE-1959) Riprap on waterward side. This entry matches the Drainage or Irrigation Structure referenced in O&M manual (HLM 2.70). FS Date: 6/7/2013

Overview of levee crown at crossing.

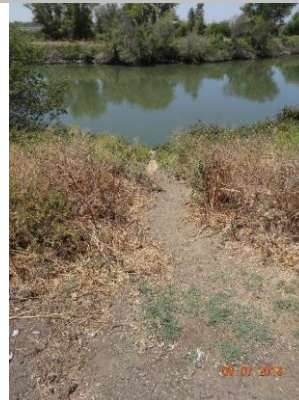
Photo 2 of 2 : UCIP\_SP\_2016\_18945\_31609.jpg

Overview of waterward side. Pipe is mostly buried through waterward side.

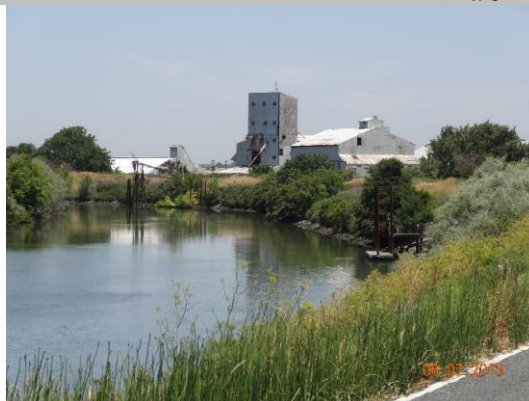
Photo 1 of 2 : UCIP\_SP\_2016\_32538\_58994.jpg

Comment Code					
Inspector Comment					
FS_ID:32538					
DS_ID:21048					
EP_NO: N/A					
Repair Type: Non-Urgent					
Crossing Status: Found					
UCIP Comments: Dense vegetation limits the inspector's visibility to identify signs of pipe failure (leaks) through the waterward slope. Recommend removing vegetation along pipe alignment to conduct proper inspection of structure and appurtenances. Need to find owner of crossing and determine if permit number is available.					
FIELD_STRUCT_DESC: 12-inch steel pipe through the levee, 5.0 feet below the crown. Pump on pile structure in stream. Service pole on landward slope. Concrete standpipe at landward toe. (USACE-1959). This entry matches the Drainage or Irrigation Structure referenced in O&M manual (HLM 3.80).					
FS Date: 6/7/2013

Photo taken downstream of structure.

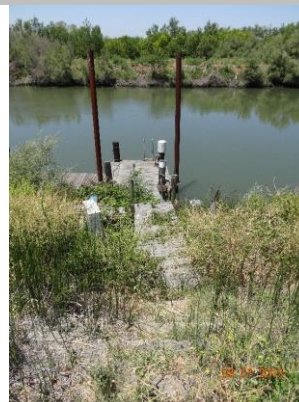
Photo 2 of 2 : UCIP\_SP\_2016\_32538\_58999.jpg

View of waterward side. Dense vegetation throughout waterward side. Walkway visible and support piles.

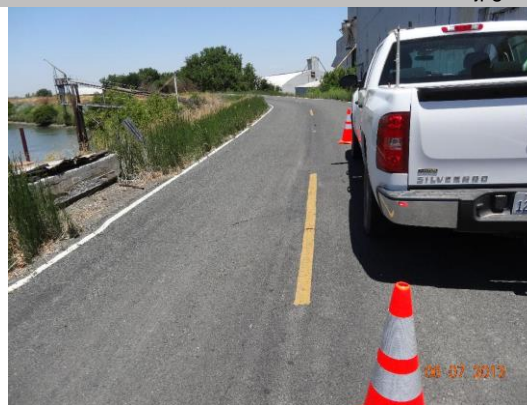
Photo 1 of 2 : UCIP\_SP\_2016\_32540\_59007.jpg

LM Start	3.65	Rating **	M	Issue No.	136
LM End	3.65	Issue Type +	En	Location *	LS
Category	Supplemental			GPS Latitude/Longitude	
				Start	End
Item	DWR UCIP Field Study			38.267818 °	38.267818 °
				-121.640521 °	-121.640521 °
DWR ID					
Comment Code					
Inspector Comment					
FS_ID:32540 DS_ID:21050 EP_NO: N/A Repair Type: Non-Urgent Crossing Status: Found UCIP Comments: Unable to properly inspect structure--limited access. Also unable to determine if structure is still in use. Levee logs indicate this crossing is abandoned. If structure is no longer used-how to prevent water from flowing through levee during flood season. If structure no longer in use owner will need to coordinate with CVFPB. FIELD_STRUCT_DESC: Abandoned 5.5 x 5.5 foot concrete tunnel through the levee, 6.5 feet below the crown. FS Date: 6/7/2013

View of narrow levee crown.

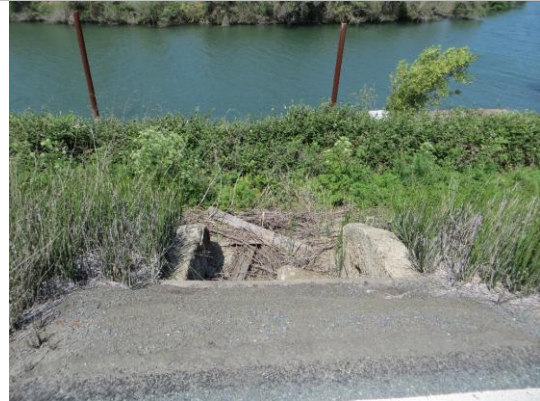
Photo 2 of 2 : UCIP\_SP\_2016\_44743\_73941.jpg

LM Start	3.66	Rating **	U	Issue No.	148 (cont)
LM End	3.66	Issue Type +	En	Location *	LS
Category	Supplemental			GPS Latitude/Longitude	
				Start	End
Item	DWR UCIP Field Study			38.268003 °	38.268003 °
				-121.640474 °	-121.640474 °
DWR ID					
Comment Code					
Inspector Comment					
FS_ID:44743 DS_ID:21051 EP_NO: N/A Repair Type: Urgent Crossing Status: Found UCIP Comments: Concrete deteriorating. Pipe open on both ends. Appears abandoned and if so should be done so properly. FIELD_STRUCT_DESC: 5.5 x 6.0 foot concrete tunnel through the levee, 2.5-feet below the crown. FS Date: 4/23/2015

Concrete tunnel and wingwalls visible on WS slope.

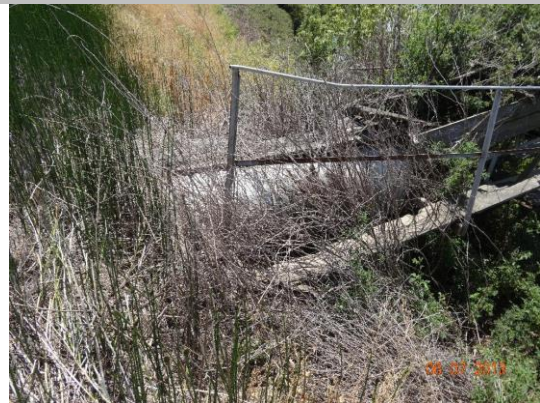
Photo 1 of 2 : UCIP\_SP\_2016\_19662\_33420.jpg

LM Start	3.68	Rating **	M	Issue No.	132
LM End	3.68	Issue Type +	En	Location *	LS
Category	Supplemental			GPS Latitude/Longitude	
				Start	End
Item	DWR UCIP Field Study			38.268278 °	38.268278 °
				-121.640377 °	-121.640377 °
DWR ID					
Comment Code					
Inspector Comment					
FS_ID:19662 DS_ID:21052 EP_NO: N/A Repair Type: Non-Urgent Crossing Status: Found UCIP Comments: Need to abandon structure properly--contact owner. Also if crossing is still in use--recommend removing vegetation along pipe alignment to conduct proper inspection of structure and appurtenances. FIELD_STRUCT_DESC: 36-inch pipe through the levee, 5.0 feet below the crown. Grain loading auger sleeved through the pipe. Grain loading system on platform in channel. (Permit No. 1503, 1959). This entry matches the Drainage or Irrigation Structure referenced in O&M manual (HLM 4.00). FS Date: 6/7/2013

View of waterward side. Pipe visible through dense vegetation.

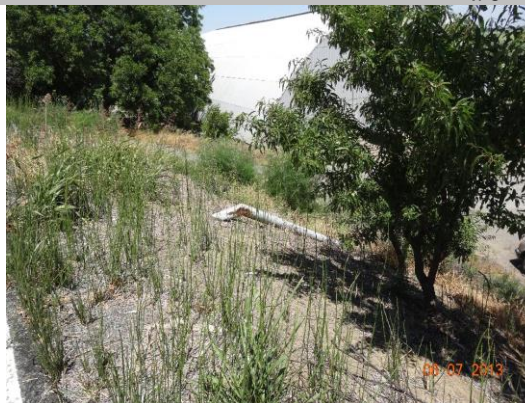
Photo 2 of 2 : UCIP\_SP\_2016\_43524\_33424.jpg

LM Start	3.70	Rating **	M	Issue No.	153 (cont)	
LM End	3.70	Issue Type +	En	Location *	LS	
Category	Supplemental			GPS Latitude/Longitude		
				Start		End
Item	DWR UCIP Field Study			38.268570 °		38.268570 °
				-121.640408 °		-121.640408 °
DWR ID						
Comment Code						
Inspector Comment						
FS_ID:43524 DS_ID:21053 EP_NO: N/A Repair Type: Non-Urgent Crossing Status: Found UCIP Comments: Dense vegetation limits the inspector's visibility to identify signs of pipe failure (leaks) through the waterward slope. Recommend removing vegetation along pipe alignment to conduct proper inspection of structure and appurtenances. FIELD_STRUCT_DESC: 6-inch pipe through the levee, 2.5 feet below the crown. Pump in pump house on waterward slope. (USACE-1959). This entry matches the Drainage or Irrigation Structure referenced in O&M manual (HLM 4.00). (Permit No. 1557, 1951). FS Date: 6/7/2013

View of landward side. Pipe visible.

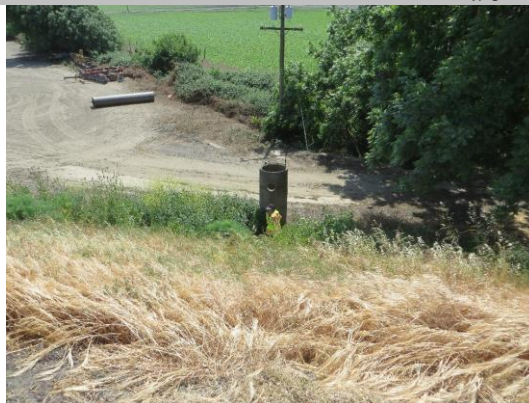
Photo 1 of 2 : UCIP\_SP\_2016\_44746\_73944.jpg

LM Start	4.31	Rating **	M	Issue No.	149
LM End	4.31	Issue Type +	En	Location *	LS
Category	Supplemental			GPS Latitude/Longitude	
				Start	End
Item	DWR UCIP Field Study			38.275955 °	38.275955 °
				-121.638626 °	-121.638626 °
DWR ID					
Comment Code					
Inspector Comment					
FS_ID:44746					
DS_ID:21107					
EP_NO: N/A					
Repair Type: Non-Urgent					
Crossing Status: Indicator Found					
UCIP Comments: Need to verify type of abandonment.					
FIELD_STRUCT_DESC: *ABANDONED* 10-inch pipe through the					
levee, 4.8 feet below the crown. 34-inch concrete standpipe on LS toe.					
10-inch diameter hole in standpipe where abandoned pipe once					
connected (USACE-1959). This entry matches the Drainage or					
Irrigation Structure referenced in O&M manual (HLM 4.60).					
FS Date: 4/23/2015

34-inch diameter concrete standpipe at LS toe.

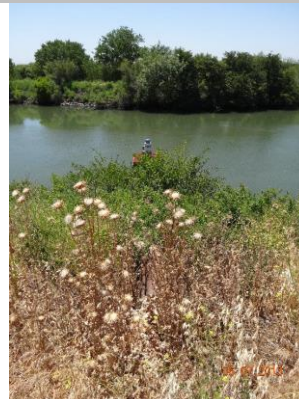
Photo 1 of 2 : UCIP\_SP\_2016\_32541\_59008.jpg

FS\_ID:32541  
DS\_ID:21071  
EP\_NO: N/A  
Repair Type: Non-Urgent  
Crossing Status: Found  
UCIP Comments: --Contact owner--Dense vegetation limits the inspector's visibility to identify signs of pipe failure (leaks) along the waterward and landward slopes. Recommend removing vegetation along pipe alignment to conduct proper inspection of structure and appurtenances. Walkway and siphon breaker not found.  
FIELD\_STRUCT\_DESC: 12-inch concrete pipe through the levee, 2.5 feet below the crown. Cutoff wall around pipe at center of levee. Siphon breaker on apex of pipe at shoulder. Pump on pile structure in stream. Walkway access to pump. (USACE-1959). This entry matches the Drainage or Irrigation Structure referenced in O&M manual (HLM 5.10).  
FS Date: 6/7/2013

View of waterward side. Pump located on pile structure in stream.

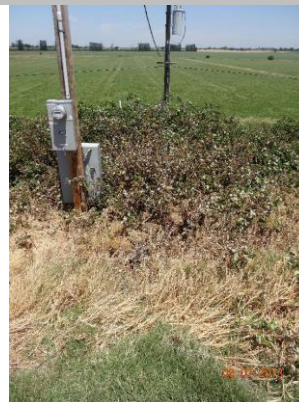
Photo 2 of 2 : UCIP\_SP\_2016\_32541\_59009.jpg

View of landward side. Power source and control box on landward side.

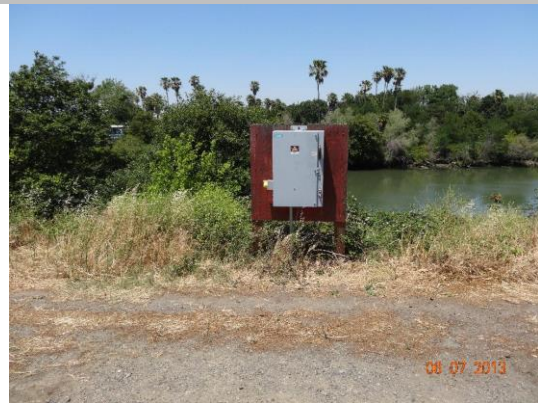
Photo 1 of 2 : UCIP\_SP\_2016\_19666\_33435.jpg

LM Start	5.43	Rating **	M	Issue No.	133
LM End	5.43	Issue Type +	En	Location *	LS
Category	Supplemental			GPS Latitude/Longitude	
				Start	End
Item	DWR UCIP Field Study			38.288950 °	38.288950 °
				-121.644183 °	-121.644183 °
DWR ID					
Comment Code					
Inspector Comment					
FS_ID:19666 DS_ID:21054 EP_NO: N/A Repair Type: Non-Urgent Crossing Status: Found UCIP Comments: Need to find owner and permit number authorizing work. Dense vegetation limits the inspector's visibility to identify signs of pipe failure (leaks) along the waterward and landward slopes. Recommend removing vegetation along pipe alignment to conduct proper inspection of structure and appurtenances. FIELD_STRUCT_DESC: 12-inch pipe through the levee, 3.0 feet below the crown. Pump on pile structure in stream. FS Date: 6/7/2013

Overview of waterward side. Control box located near levee crown.

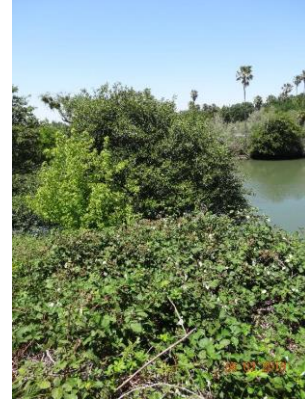
Photo 2 of 2 : UCIP\_SP\_2016\_19666\_33434.jpg

LM Start	5.43	Rating **	M	Issue No.	133 (cont)
LM End	5.43	Issue Type +	En	Location *	LS
Category	Supplemental			GPS Latitude/Longitude	
				Start	End
Item	DWR UCIP Field Study			38.288950 °	38.288950 °
				-121.644183 °	-121.644183 °
DWR ID					
Comment Code					
Inspector Comment					
FS_ID:19666 DS_ID:21054 EP_NO: N/A Repair Type: Non-Urgent Crossing Status: Found UCIP Comments: Need to find owner and permit number authorizing work. Dense vegetation limits the inspector's visibility to identify signs of pipe failure (leaks) along the waterward and landward slopes. Recommend removing vegetation along pipe alignment to conduct proper inspection of structure and appurtenances. FIELD_STRUCT_DESC: 12-inch pipe through the levee, 3.0 feet below the crown. Pump on pile structure in stream. FS Date: 6/7/2013

Structure visible through the dense vegetation. Limited access unable to inspect.

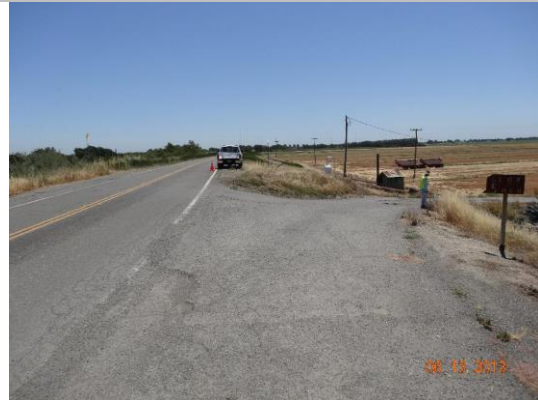
Photo 1 of 2 : UCIP\_SP\_2016\_32542\_59022.jpg

Comment Code					
Inspector Comment					
FS_ID:32542 DS_ID:21059 EP_NO: N/A Repair Type: Non-Urgent Crossing Status: Found UCIP Comments: Need to determine status of crossing. Horizontal and vertical cracks present on stand pipe located on landward side. Dense vegetation limits the inspector's visibility to identify signs of pipe failure (leaks) along the waterward slope. Recommend removing vegetation along pipe alignment to conduct proper inspection of structure and appurtenances. FIELD_STRUCT_DESC: 12-inch steel pipe through the levee, 6.0 feet below the crown. 2-inch conduit line through levee. Pump and gate valve on waterward slope. Pipe exposed on landward side. (USACE-1959). This entry matches the Drainage or Irrigation Structure referenced in O&M manual (HLM 6.90). FS Date: 6/13/2013

Overview of levee crown at crossing.
